# Your survey and valuation report

10th October 2022

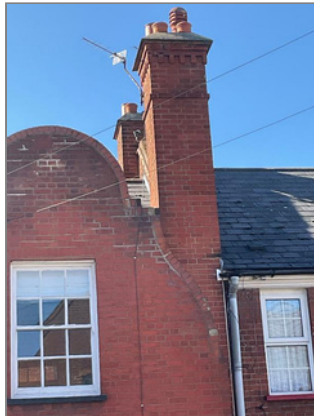
Photo - 2

Damp noted internally indicating likely defect to mortar where chimneys meet roof. Condition Rating 3. Remedial works required most likely to the joints where chimneys meet roof.

Brick stacks pass up through the building to roof level. They were found to be level and upright with no significant structural issues noted. Brickwork and pointing are worn although not significantly enough to warrant urgent repairs at this time.

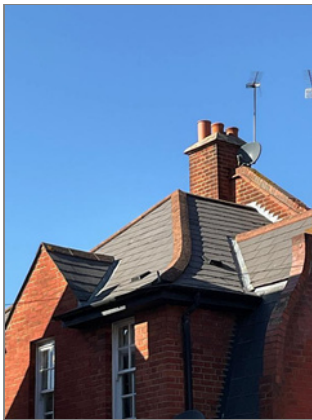
Photo - 3

At roof level where the roof meets the walls there are metal flashings in place. No significant issues were noted in this regard and there was no evidence of damp penetration internally at the time of inspection.

Condition rating 1. No repair is currently needed. The property must be maintained in the normal way.

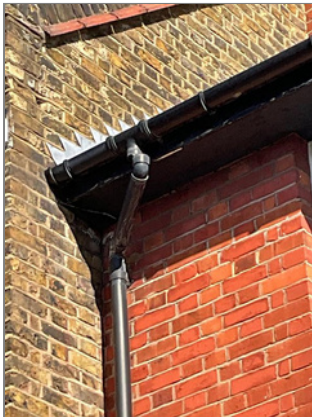
Photo - 4

Rainwater fittings are of replacement plastic specification. To the majority was no evidence of blockage, overflow or damp penetration due to defective fittings at the time of inspection, however viewing in wet weather is recommended to confirm.

To rear Downpipe has come away which will lead to damp penetration. Refitting is required. Condition rating 3 These works should be carried out soon.

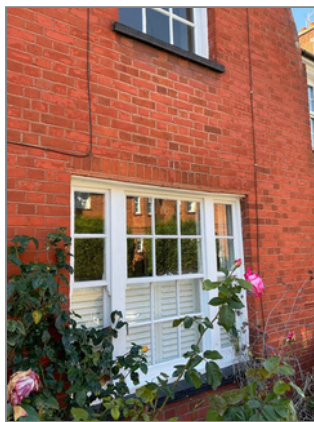
Photo - 5

Main walls are of solid brick construction. They were found to be level and upright with openings approximately squarely incorporated. There was no evidence of a significant structural issue or any evidence of movement or subsidence issues at the time of inspection. Brickwork and pointing were free from serious defect.

High damp readings were noted rear left living room. Condition rating 3. You are advised to instruct a specialist Property Care Association and Wood Protection Association registered contractor to make a full examination of walls and timbers adjoining dampness including under floor areas and provide a report and quotation. Where walls have added boarded finish, it can mask issues such

Plaster on walls affected by rising damp contains salts from the soil which are hygroscopic and attract moisture from the air. Until such contaminated plaster is removed and replaced with a special plaster, the walls will remain damp. It is normally necessary to remove the plaster from the affected walls up to a height of 1 metre above the floor and re-plaster. The damp proofing contractors guarantee may not be fully effective until such re-plastering has been carried out. A close inspection of timbers adjacent to damp affected walls must also be undertaken. If this has occurred over a period of time, those timbers will themselves be damp affected.

Slight bowing over living opening front noted. This may be just in the tiled finish. There is a risk of issue to lintel support however there was no other evidence to suggest this is the case.

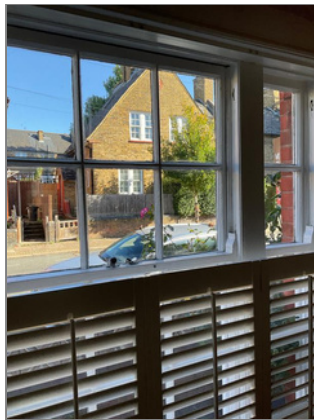
Photo - 7

Windows are of timber single glazed sash units. Single glazing is poor for insulation and security purposes. On-going maintenance and management will be required as normal for sash windows of this age, including to sash cords and weighting, although significant works are not currently needed. There are worn and cracked glass panels. Deteriorating and broken sash cords also noted. On-going maintenance of finishes, particularly to lower ends, should be anticipated internally due to condensation and externally due to weathering. Condition rating 2. These works should be carried out soon.

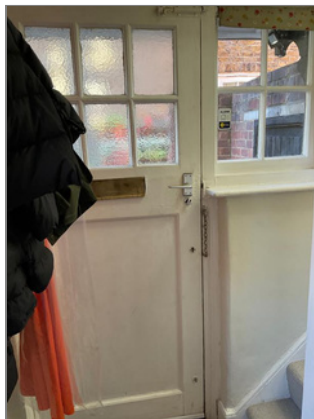
Photo - 8

The timber front door was free from serious defect; however, you should be aware that single glazing is poor for insulation and security purposes.

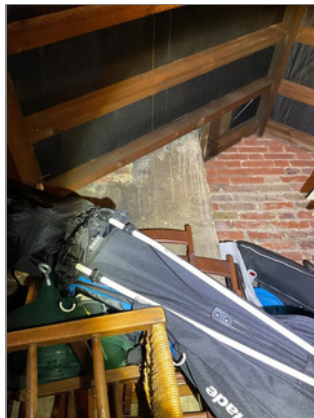
Photo - 9

The roof space is accessed via a hatch on the landing. Lining was free from serious defect.

Structure was in a satisfactory condition.

Insulation was adequate.

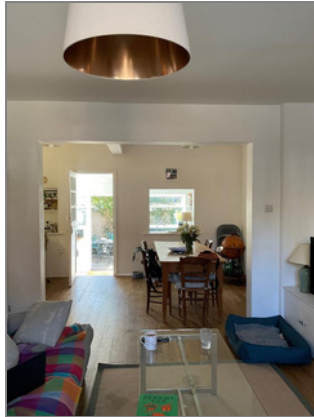
Photo - 11

Internal walls are of solid and stud specification with plaster finishes and decorative finishes over these. Walls were found to be level and upright with no significant distortion noted. Plaster finishes were free from serious defect.

The original living room wall has been partly removed. No problems were noted and brickwork would appear to be adequately supported. Enquiries should be made of the Local Authority with regard to this, although if there is no record it is unlikely any action will be taken.

You are advised to instruct a specialist Property Care Association and Wood Protection Association registered contractor to make a full examination of walls and timbers adjoining dampness including under floor areas and provide a report and quotation. See external walls.

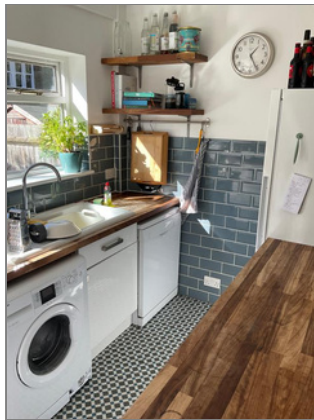
Photo - 12

Kitchen fittings and built-in cupboards were free from serious defect at the time of inspection.

These are subject to your own requirements. Condition rating 1. The property must be maintained in the normal way.

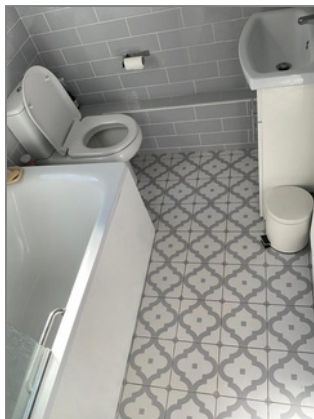
Photo - 13

Bathroom fittings were free from significant impact damage or leakage at the time of inspection. The pipework is hidden within construction. Condition rating 1. The property must be maintained in the normal way.

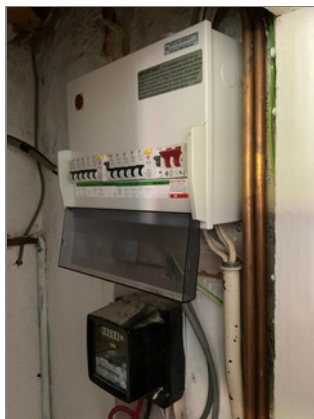
Photo - 14

The consumer board is located under the stairs. Installation certification for any replacement items such as light fittings should be in place and confirmed. In the absence of such it would indicate works by a non-compliant contractor and therefore be a safety risk. The electrical system may be below current standards. For example, the electrical system may not be covered by a current inspection and testing certificate. This is a safety hazard (see section J3 Risks). You should ask an appropriately qualified person to inspect the electrical system.

Condition rating 2. Further information required.

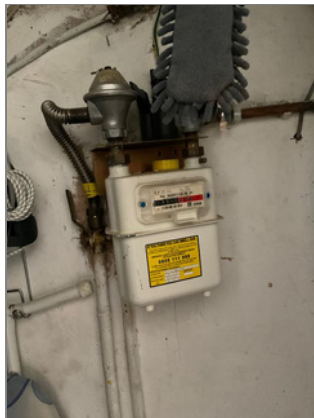
Photo - 15

The meter is located under the stairs. There was no smell of gas within the property at the time of inspection. The gas supply system may not be covered by a current inspection and testing certificate (see section I3 Risks). You should ask an appropriately qualified person to inspect the gas installation system now. Condition rating 2. Further information required.

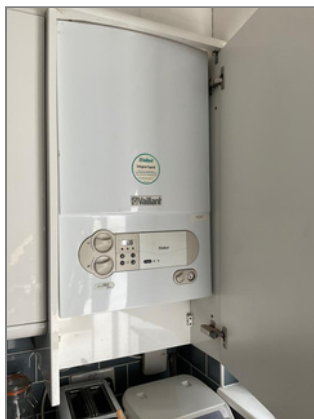
Photo - 16

Central heating to radiators and hot water is supplied by a combination gas boiler located in the kitchen. There was no outward evidence to suggest it is defective. Installation certification and service records for the boiler should be in place and confirmed. In the absence of such it would indicate works by a non-compliant contractor and therefore be a safety risk.

There is no evidence that the heating system has been checked or serviced within the last 12 months. This is a safety hazard. This should be resolved now. Condition rating 2. Further information required.
