LEVEL 3

Your survey report

14th October 2022

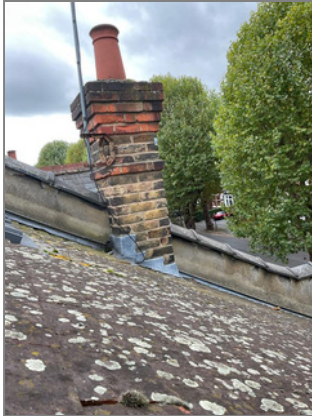
Photo - 3

The chimney appears to be in a structurally sound condition with no evidence of any unacceptable thermal cracking or deviation from vertical. I am unable to comment on the condition of the cement at the top of the stacks as this could not be viewed from ground level. It is not unusual to find such cement fillets are defective and so repairs should be anticipated.

There are disused flues. The redundant chimney pots should be removed and the flues capped off and ventilated to prevent moisture penetration and condensation.

Brickwork and pointing between was in a reasonable condition and no significant issues were noted at the time of inspection. There are metal flashings at the base of the stack where it meets the roof and no evidence to suggest any current leakage, although this has leaked in the past. These are an area of weakness within a building of this age, and maintenance should be anticipated should be anticipated in the medium-term to prevent dampness occurring which can affect roof timbers.

Condition rating 1. A close inspection should be undertaken when next carrying out works at roof level. Due to exposure from weathering, minor repairs are often required to help prevent damp penetration.

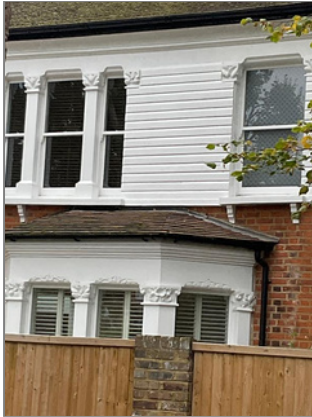
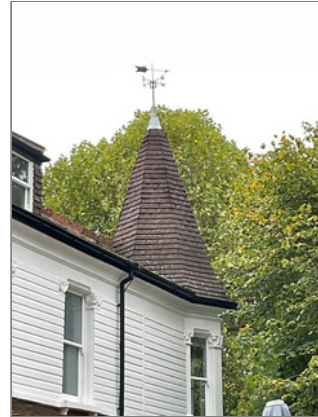
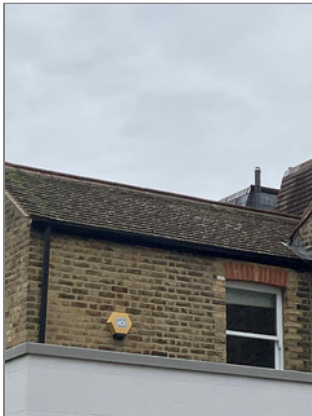
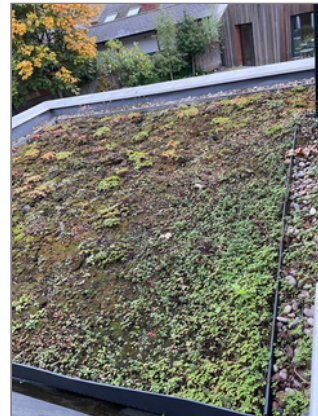
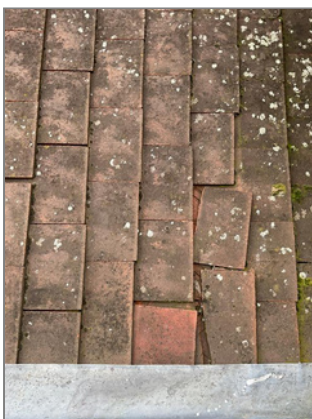
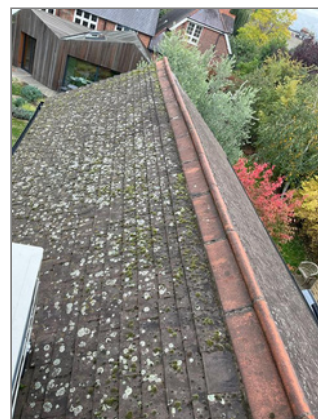
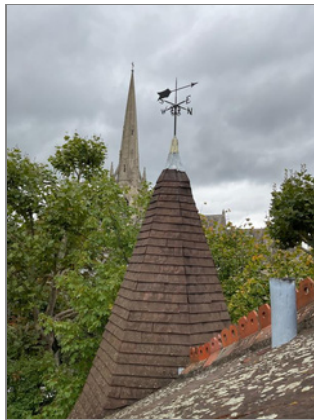
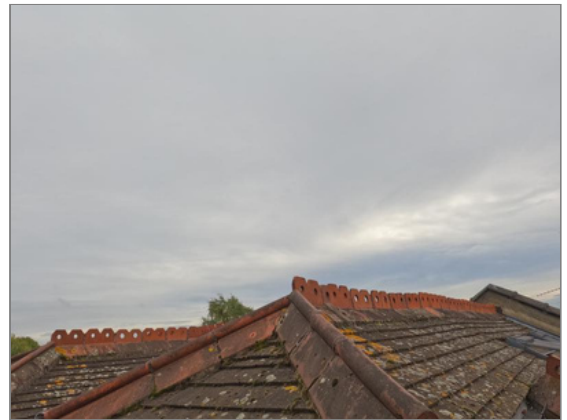
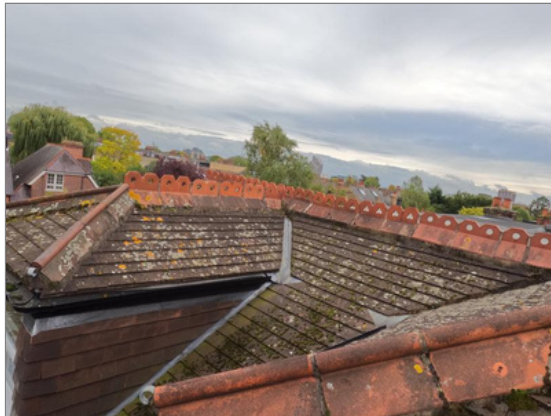
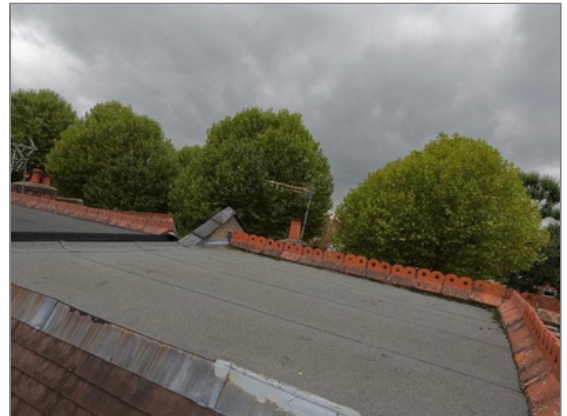
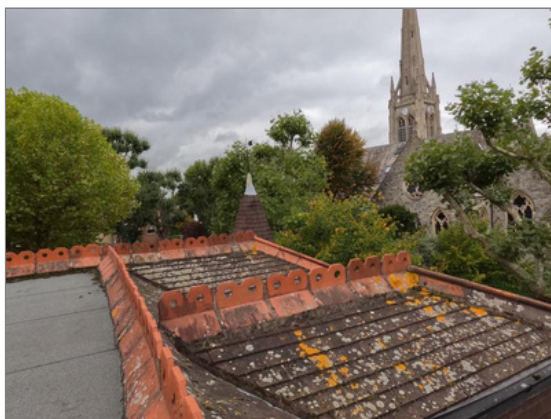
The main roof slopes were noted to be acceptably even and free from any undue distortion, deflection or distress which indicates that the roof frame is dealing adequately with the imposed load of the roof covering.

The ridge tiles and roof tiles were in a reasonable condition for age, however there are slipping tiles to all of the roof slopes and cracked and deteriorating tiles to the central rear which will require replacement. Normal maintenance elsewhere will be needed in the short to medium-term and on an on-going basis, due to the age of the roof cover.

To the top of the conical section, the weathervane has been taped in-situ which is a temporary repair and this may be a weak joint. Inspection is recommended and remedial action likely to be required in the short term.

The upper flat roof is covered in roofing felt. Enquiries of the vendor should confirm when this was introduced. There was no evidence of current damp penetration. Felt coverings to flat roofs have limited durability and can require patching repairs at any time. Full stripping and re-felting is normally needed at 10-15 year intervals. Modern elastomeric felts or fibre glass are available which have better durability and resistance to splitting than traditional felt and although more expensive, should be specified when seeking estimates for re-felting. When the flat roof is next refurbished, the insulation and ventilation to the roof structure should be checked and upgraded if necessary.

To the rear single storey section there is a living roof with plant growth upon it. There was no evidence of damp penetration beneath. Enquiries of the vendor should provide a warranty for the roof and the on-going maintenance requirements with potential costs in this regard.

Condition rating 2. I recommend you instruct a competent roofing contractor to inspect and quote for remedial action.

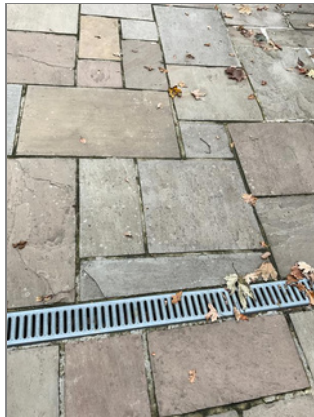
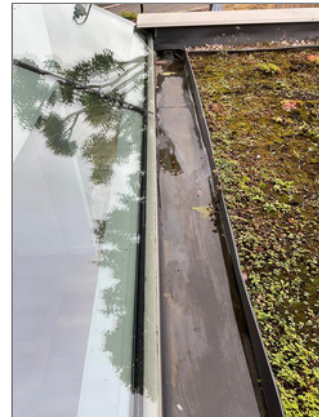
which appear satisfactory from ground level. I would stress, however, that it was not raining at the time of my inspection and I cannot therefore comment as to whether the gutters and downpipes are free from leakage. I recommend that the fittings are checked during a period of rainfall in order to establish whether there are any defective joints or other defects requiring attention.

To the rear extension there is a metal valley. No significant issues were noted and there was no evidence of damp penetration.

In view of the profusion of trees in the surrounding area, it is recommended that the gutters be inspected once a year after the leaves have all fallen in the autumn to ensure that the gutters and downpipes are not blocked.

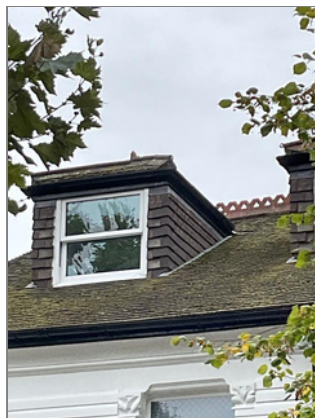
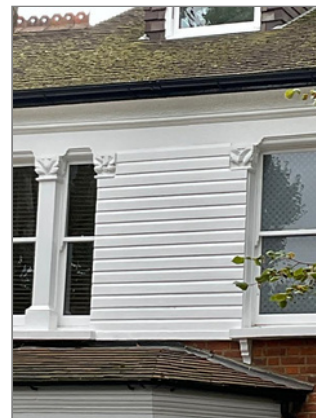
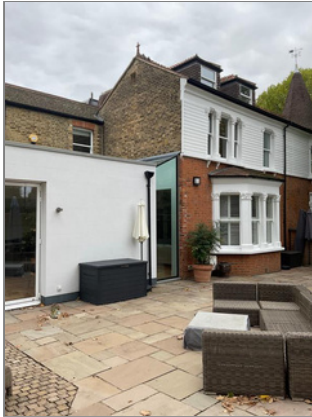
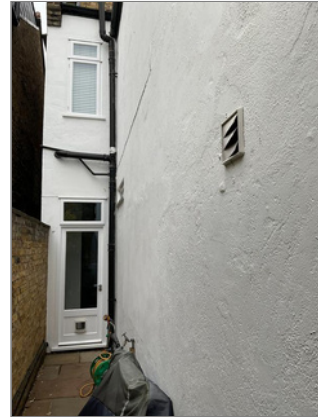
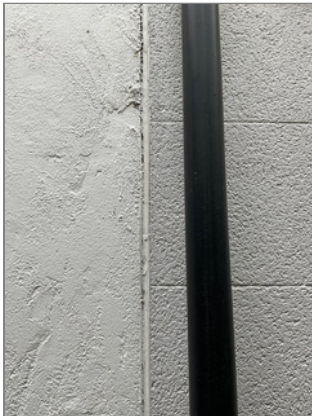
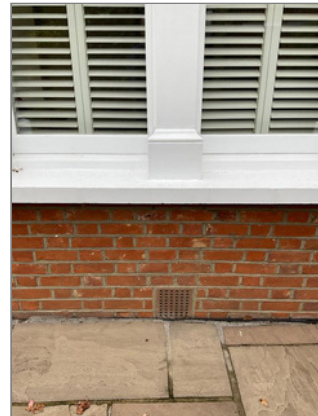
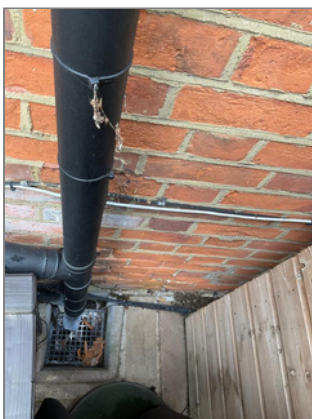
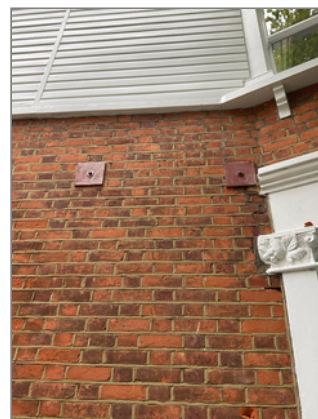
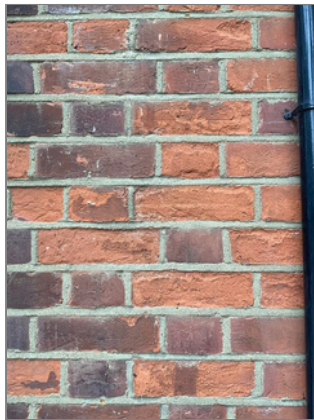
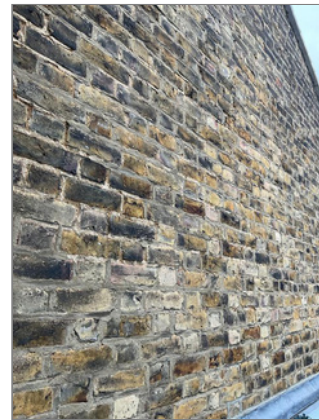
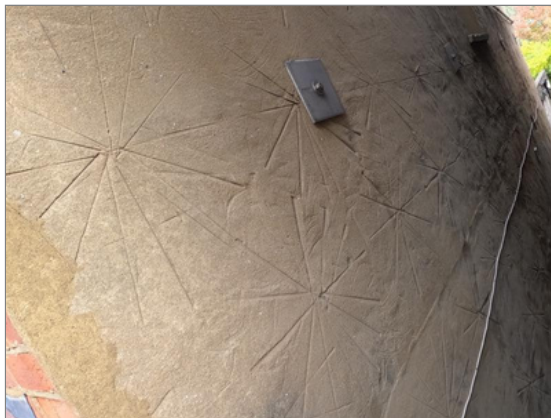
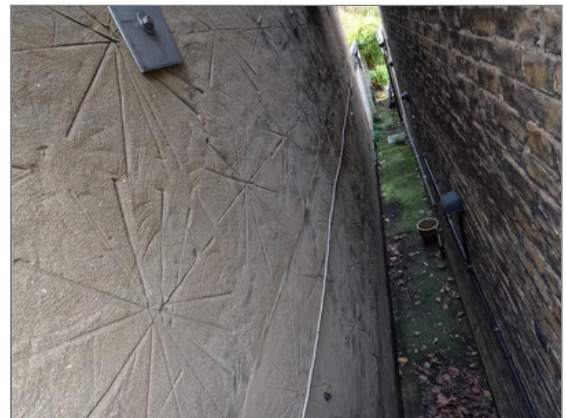
The walls were found to be generally level and upright with minor distortion consistent with age. There was some minor bowing at the upper levels, although not significant enough to warrant rebuilding.

There was some deterioration to the brickwork and pointing between brickwork as well as spalling bricks. Spalling occurs when brickwork becomes wet due to rain and if freezing conditions occur before the bricks dry out, the entrapped moisture expands and forces off the hard face of the brick, exposing the softer inner face. The worst of the areas was to the upper central rear. Patch re-pointing will be required in the short to medium-term to prevent more rapid deterioration and damp penetration. Where scaffolding is required, this increases the costs of works.

To the render there are some minor cracks and past cracks which have been filled. On-going maintenance will be required. To the right side this will involve access to the adjacent property land.

The timber clad section was free from serious defect. On-going maintenance of finishes will be required. This is an unusual finish in a property of this age. I cannot confirm whether this is original. It may also mask issues behind to both timber and walls, although there was no evidence of damp penetration internally.

When any re-pointing is carried out it is essential that the joints are raked out sufficiently, usually to a depth not less than 12mm so that the new pointing is given sufficient key. Failure to do this can result in the new pointing simply cracking and falling out over a relatively short timescale. The pointing itself should not be stronger than the bricks to which it is applied. Too high a cement content can allow shrinkage cracking.

Condition rating 3. I recommend you instruct a competent building contractor to quote for remedial action as noted above.

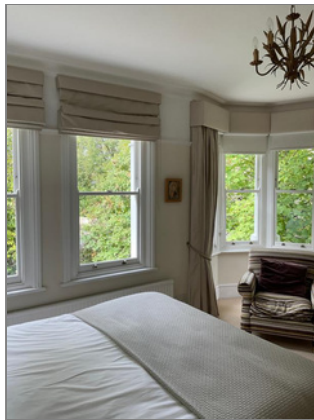
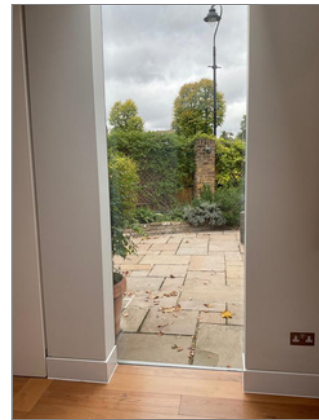
Where there is a full length glass panel to the extension, this is a potential safety hazard of which you should be aware as this can be readily walked into.

There is a timber single glazed unit to the stairs area. This will be poor for insulation and security purposes. On-going maintenance will be required of finishes to prevent wet rot.

Condition rating 1. The property must be maintained in the normal way

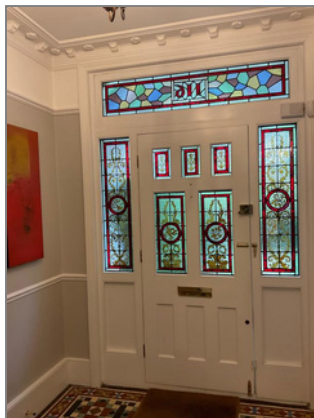
Photo - 31

The timber single glazed front door was free from serious defect although it is poor for insulation and security purposes.

Condition rating 1. The property must be maintained in the normal way.

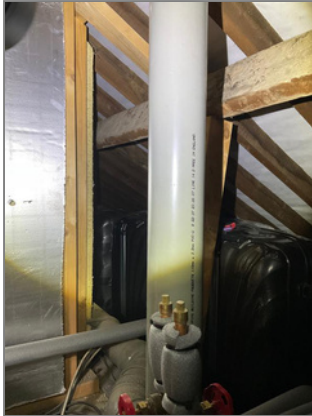
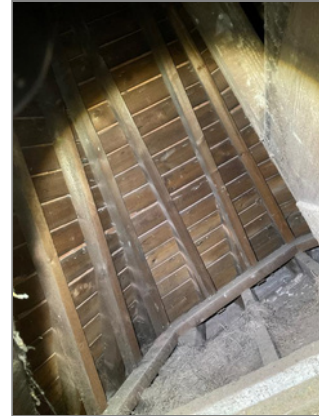
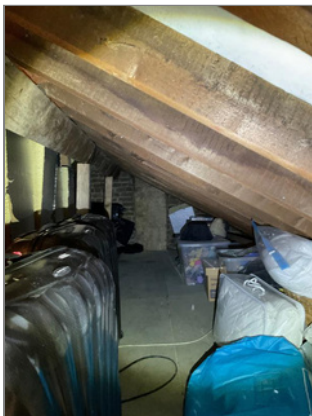
A steel beam was noted across the front within the eaves. Within the eaves, the lining was in a satisfactory condition.

To the conical section, there was no significant undue deflection of timbers or other obvious deficiencies which indicates that the framing is performing satisfactorily for its age. In this area there was no insulation and introducing insulation is recommended.

There is an old birds nest and you should be aware that this can readily reoccur.

Improving insulation generally is recommended and enquiries of the vendor should confirm whether they have any knowledge of the level of insulation to the loft extension and flat roof areas. To the rear extension this should be in accordance with building regulations at the time of construction. Inappropriate insulation to older loft conversions can cause condensation issues which can affect roof timbers.

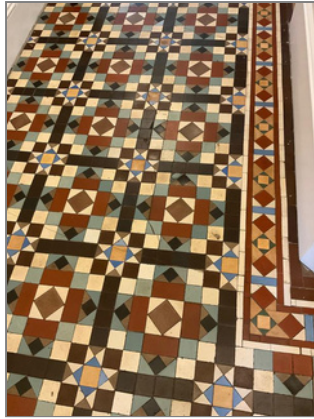
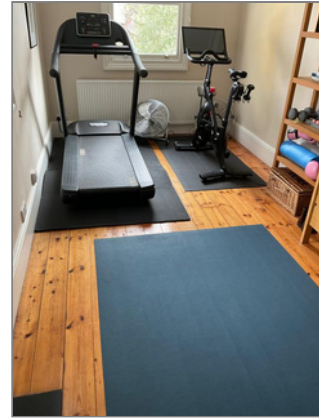
To the entrance hall there are a number of cracked and deteriorating tiles.

Condition rating 2. These tiles can be difficult to match in due to age.

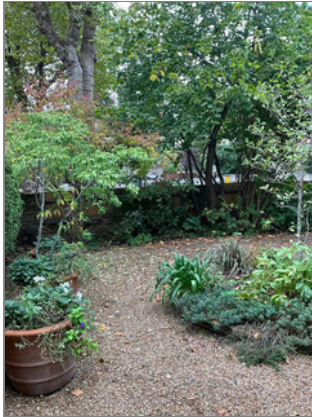
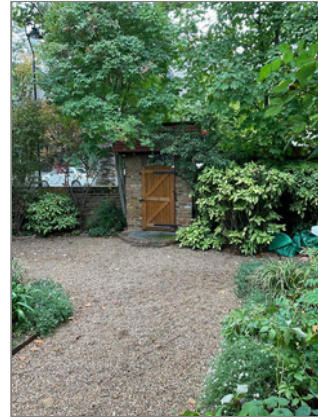
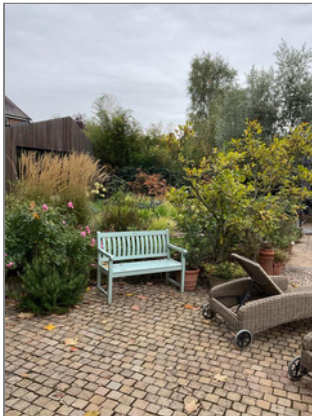
There is bamboo to the adjacent property which can impact grounds, boundaries and the outbuilding. It can also affect mortgage availability. You should be aware of the risks in this regard as it is an invasive plant.
