LEVEL 3

Your survey report

14th October 2022

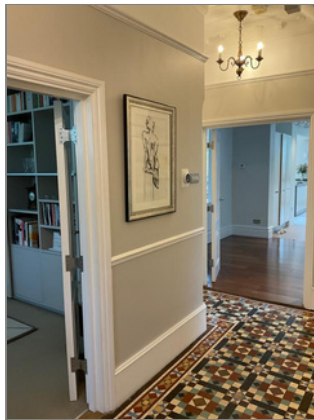
Photo - 36

Condition rating 1. The property must be maintained in the normal way.

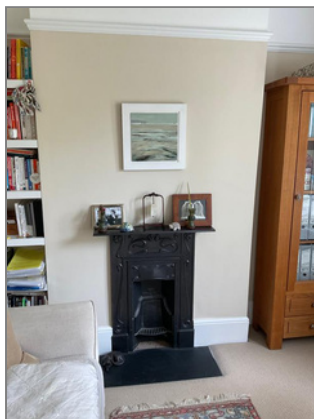
Photo - 41

Where the fireplaces are open to the ground floor, they do not appear to have been used in recent years. Where fireplaces are open, it is essential to have the flues swept if you intend to use these as working fireplaces. However, original flue linings, if any, in a building of this age are likely to have perished and require renewal. This can lead to leakage of harmful flue gases, particularly if there are redundant flues adjacent. This is a matter of safety, therefore they should not be used unless swept.

Condition rating 1. The property must be maintained in the normal way.

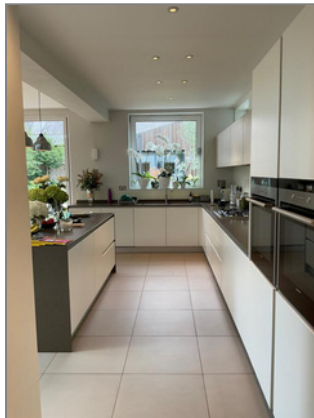
Photo - 43

Condition rating 1. The property must be maintained in the normal way.

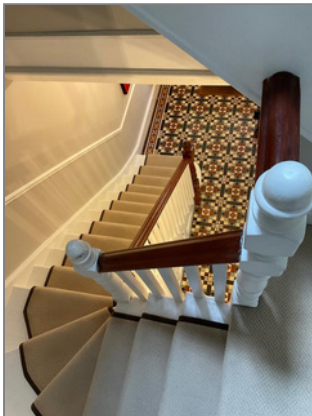
Photo - 47

There was no visible evidence of a dry rot outbreak at the time of my inspection. However, dry rot can live unseen behind plaster or in brickwork and whilst I have taken all reasonable care in our investigations, hidden dry rot could be present in areas I was unable to inspect.

Condition rating 1. A full inspection of flooring and other timbers when they become exposed is recommended as in a property of this age there is a likelihood that infestation has occurred in the past. Treatment may therefore be required. There is a risk of hidden defects.

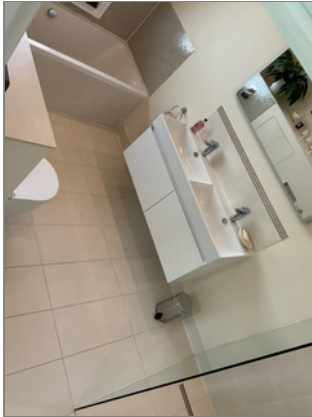
Photo - 48

The sealants around the edges of baths and wash hand basins can leak and damage adjacent surfaces. If not repaired quickly, wood rot can soon develop. The boxing and panelling around baths and other appliances can keep these problems hidden. It is important to ensure that the tiling and seals are properly made and maintained at the junction between wall surfaces and baths, showers etc., as damp penetration can lead to the development of fungal decay in concealed areas. This may not become apparent until a major attack has developed necessitating extensive and costly repairs.

Condition rating 1. The property must be maintained in the normal way.

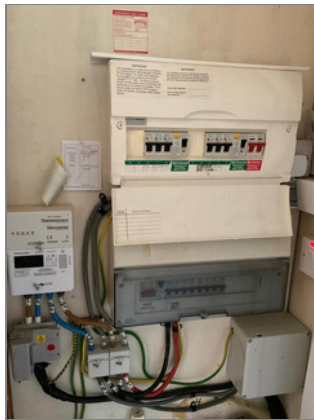
Photo - 50

In the absence of a test and report by a qualified electrician, you must understand that there may be defects to the wiring and installation which are concealed. I have not tested any switches, sockets or wiring. Over a period of time some upgrading should be anticipated as it is likely with a property of this size and age that some of the wiring will be of an older age and type.

Condition rating 2. Further information required.

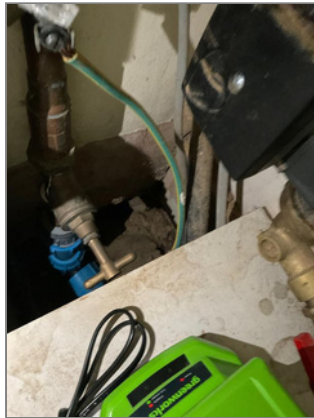
Photo - 51

In addition, if a water meter is not currently fitted it is possible that the water authority may fit a water meter following completion of your purchase and which may then reveal leakage and the need to undertake repair. It is, therefore, important that further investigation on these points should be concluded in order that the extent of any future repairing liability can be determined.

Condition rating 1. Further information required.

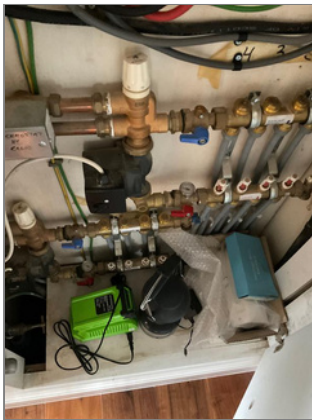
Photo - 53

Condition rating 2. Further information required.

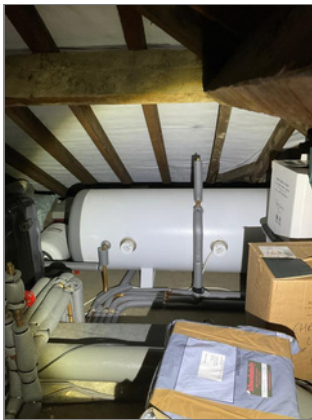
Photo - 56

Condition rating 1. Further information required.

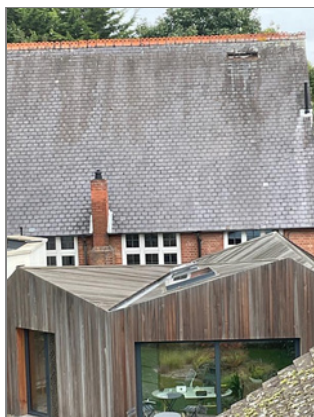
Photo - 57

Condition rating 1. The property must be maintained in the normal way.
